LARGE-SCALE TESTING OF A STEEL-CONCRETE COMPOSITE FLOOR SYSTEM
UNDER COLUMN LOSS SCENARIOS

THESIS

Submitted in partial fulfillment of the requirements
for the degree of Master of Science in Civil Engineering
in the Graduate College of the
University of Illinois at Urbana-Champaign, 2014

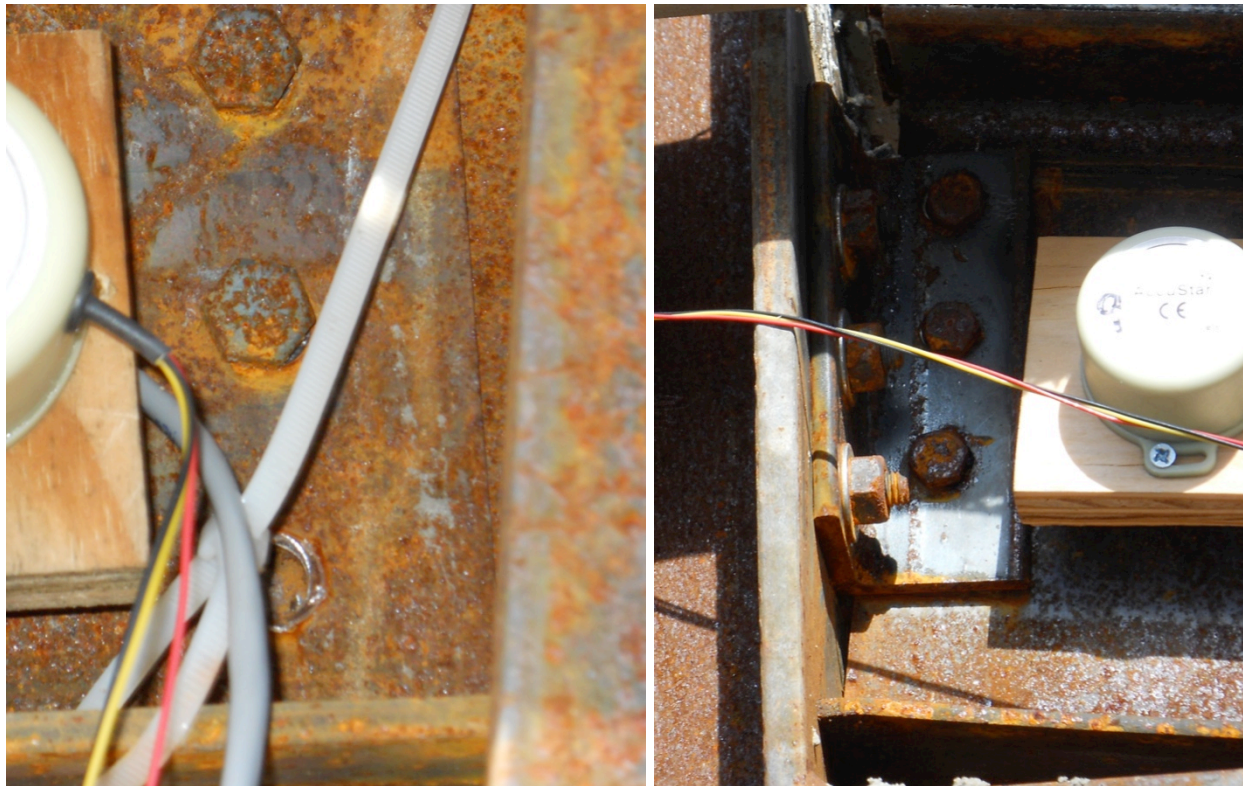
Figure 3.5 CC Test Deformation and Failure of Connections

Since the beam and girder remained essentially rigid, the deformation occurred in the connections at A3 and B4. Columns A3 and B4 had negligible rotation. The beam-to-column connection at A3 (Figure 3.5a) was a shear tab with three bolts. At first, the bolts elongated the bolt holes in the shear tab, and then the bottom bolt sheared during the last lowering of the removed column corner. Figure 3.4e shows the connection rotations at the far columns, A3 and B4. The girder-to-column connection at B4 (Figure 3.5b) was a bolted double-angle. Most of the deformation at B4 was from prying action in the double angle. With enough displacement of the removed column corner of the bay, the top bolt in the connection sheared. The girder-to-column connection acquired additional stiffness when the bottom flange of the girder began to bear on the flange of the column as the girder rotation increased.

(a) Bolt Shear in Beam Connection at A3

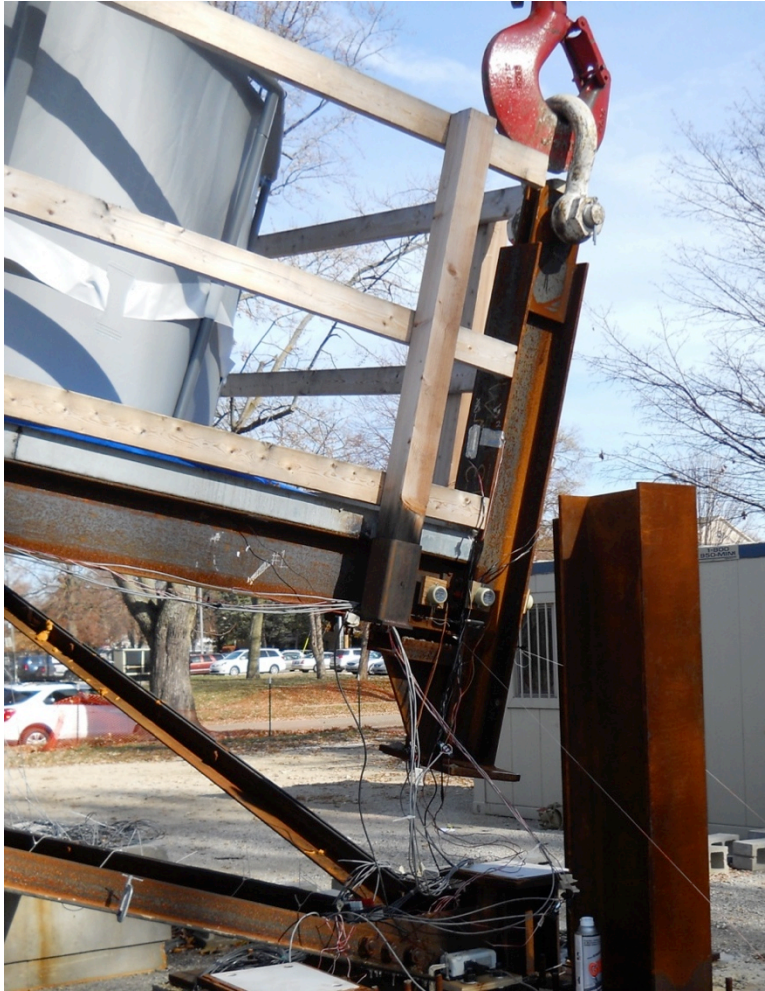
other floors above. There was almost no relative rotation between the beam or girder and the corner column stub (Figure 3.4f), indicating that the column rotated with the beam and girder. This is clearly illustrated in Figure 3.6.

Figure 3.6 CC Test Corner Column Rotated Freely with the Beam and Girder

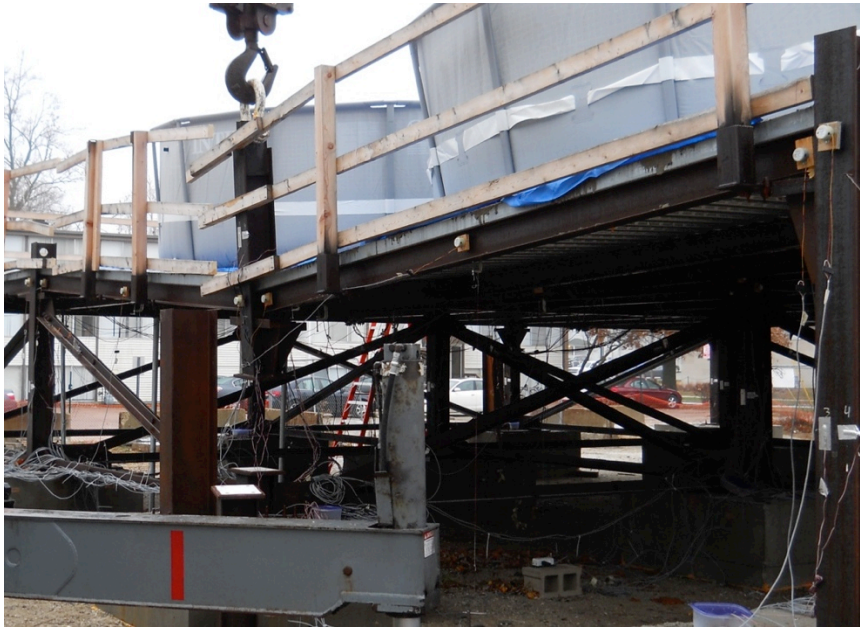
While both failed at essentially the same load, the EC-B test displayed more ductility. In the initial load increments before any concrete cracked, both floor sections had the same stiffness (defined based on vertical load-deflection behavior). At around 5 in. of displacement, the concrete slab cracked in the EC-B test, causing much larger subsequent displacements. The floor continued to resist load up to 83 psf (Figure 3.9a) and failed with 88 psf. (Figure 3.9b)

(a) Final Equilibrium (13 in. Displacement, 83 psf)

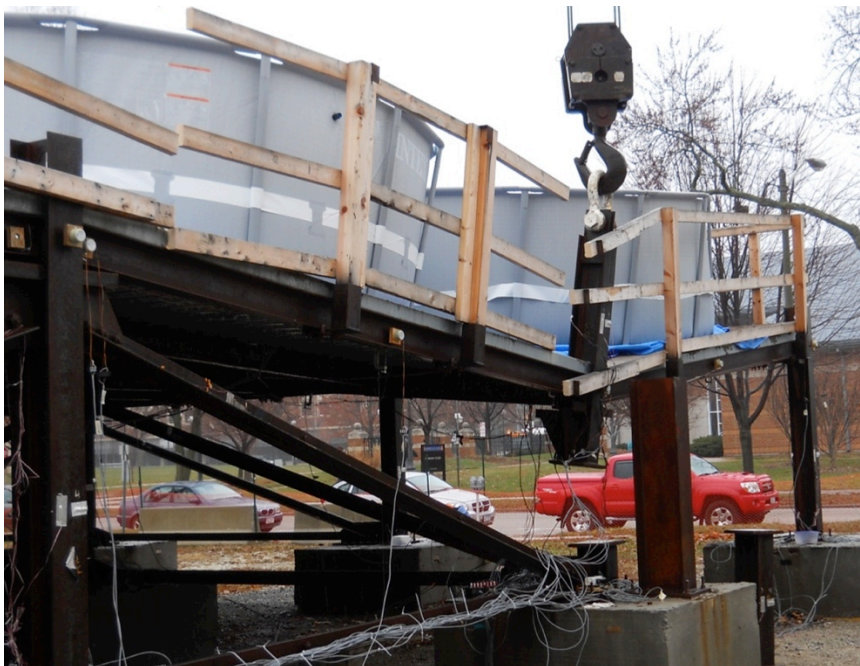
(b) Post-Failure Deformation (16 in. Displacement, 88 psf)

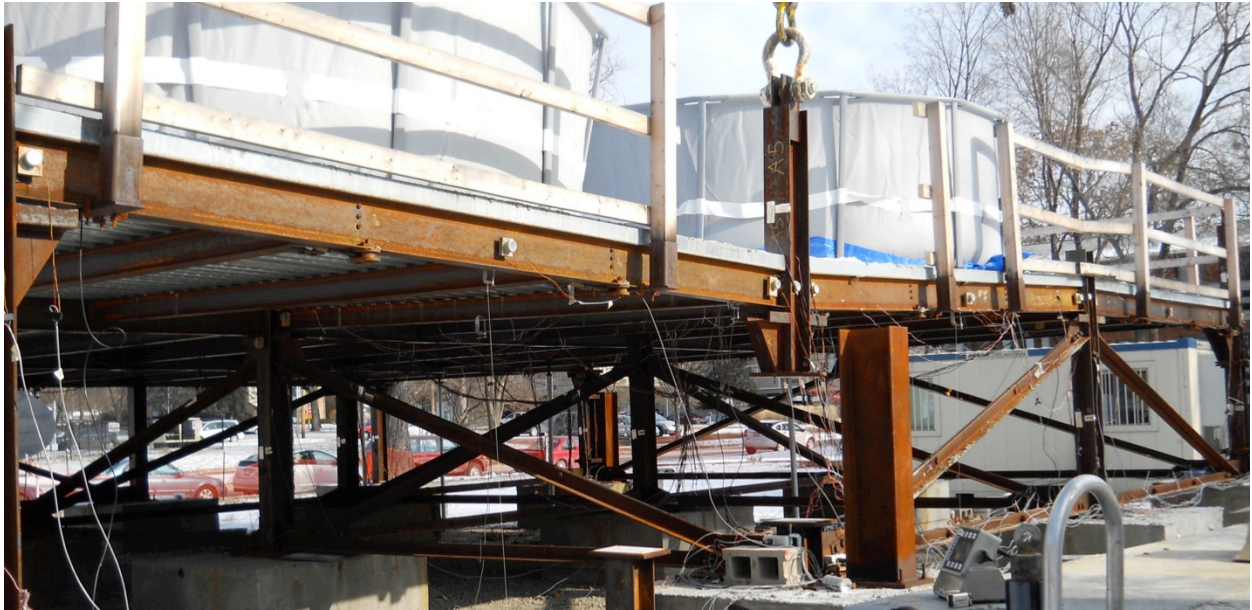
The final equilibrium for the EC-G floor bays was 84 psf (Figure 3.10a). The floor failed at 89 psf when the concrete slab cracked and the steel framing failed simultaneously (Figure

(a) Final Equilibrium (6.25 in. Displacement, 84 psf)

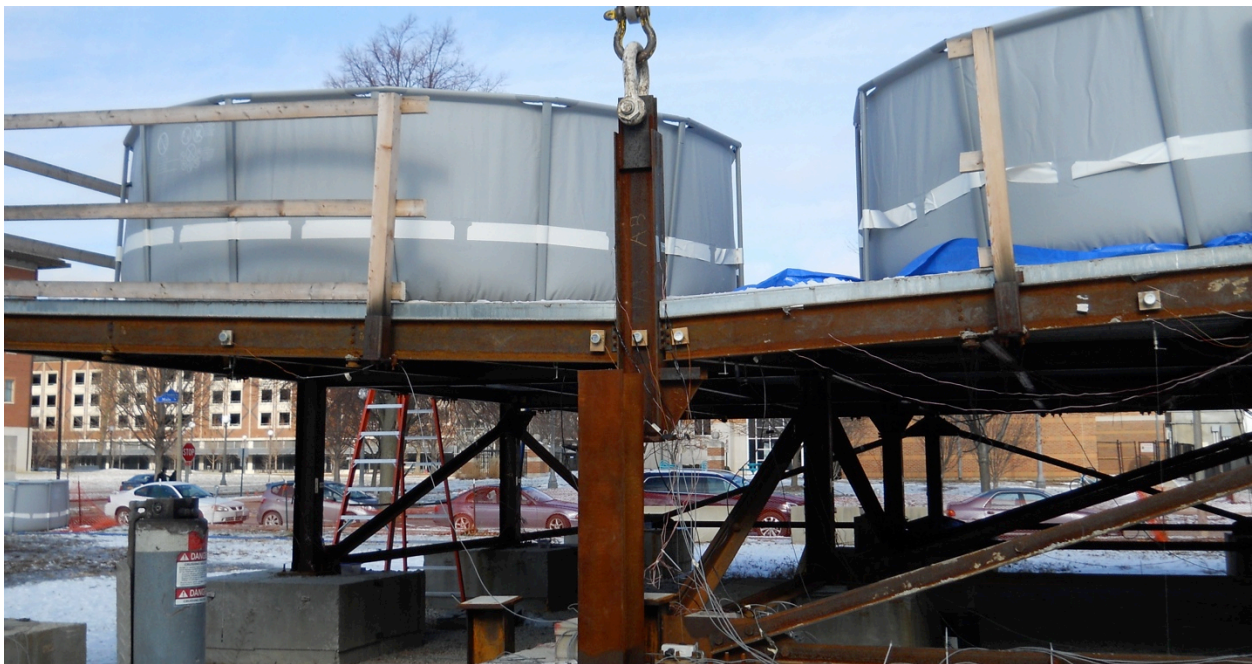
3.10b), as illustrated by the lack of ductility in the EC-G plot in the figure. The dashed lines in Figure 3.8 indicate the estimated post-failure reduction in floor load as the crane carried more load with increased displacement.

(b) Post-Failure Deformation (6.75 in. Displacement, 89 psf)

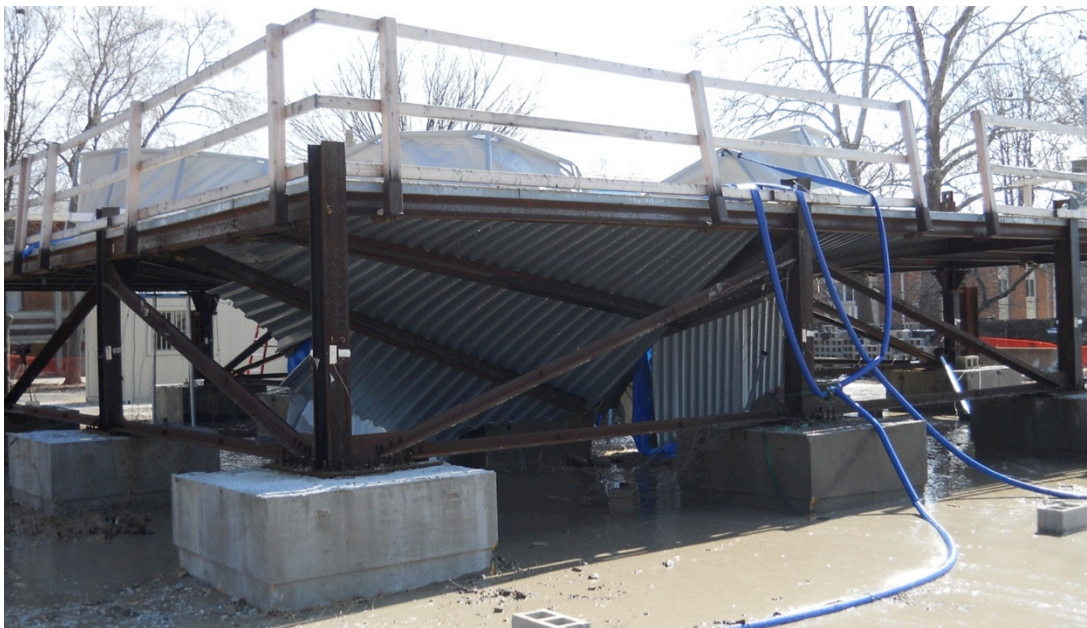
Figure 3.27 IC Test Collapse

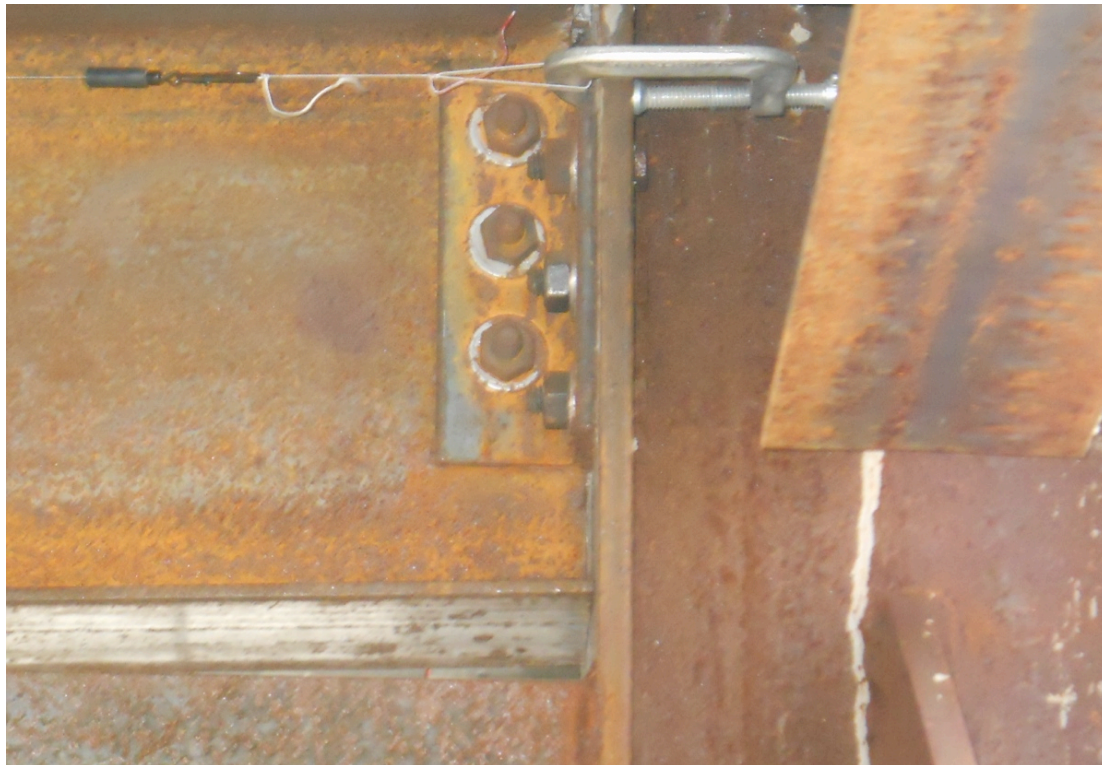
Figure 3.33 IC Test West Girder Bottom Flange Bearing on Column D2

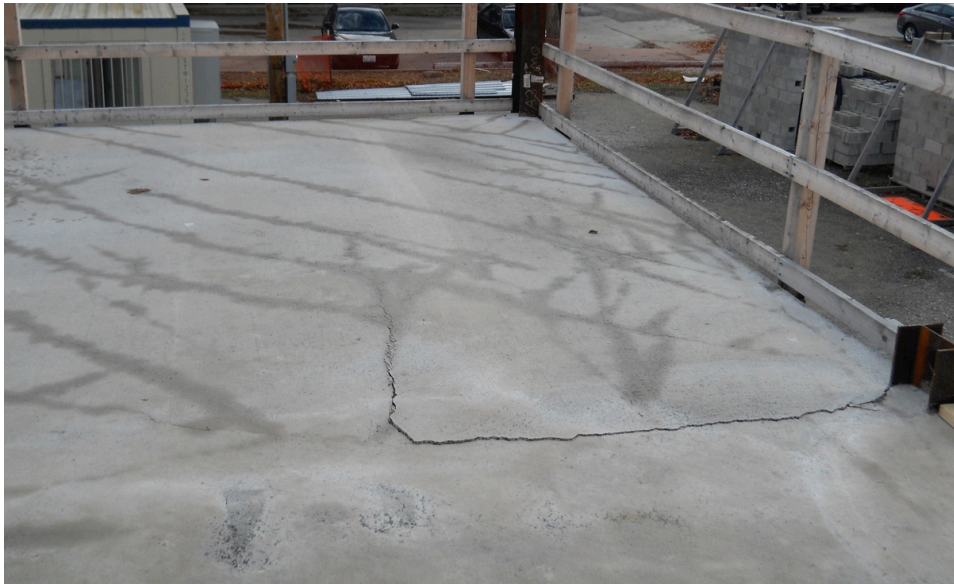
Figure 4.1 CC Test Floor Cracking Pattern

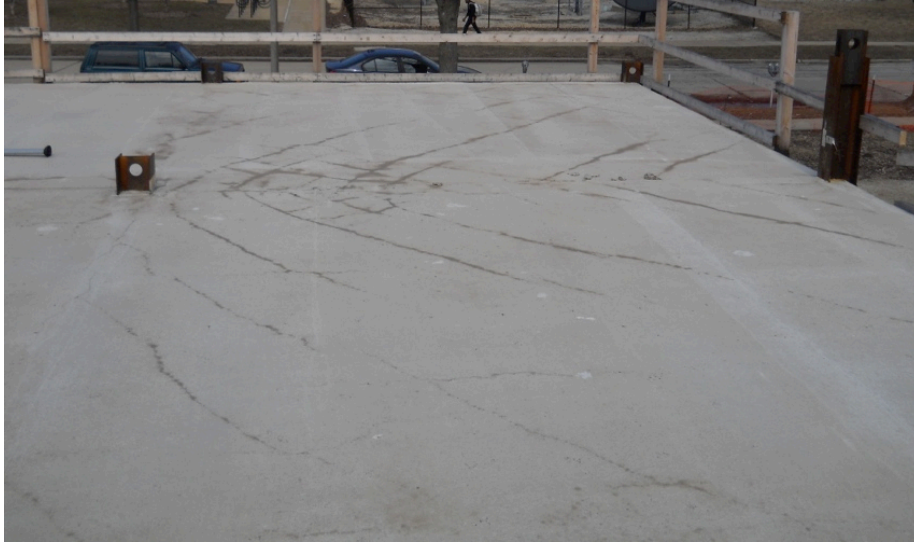
Figure 4.3 EC-B Test Floor Cracking Pattern

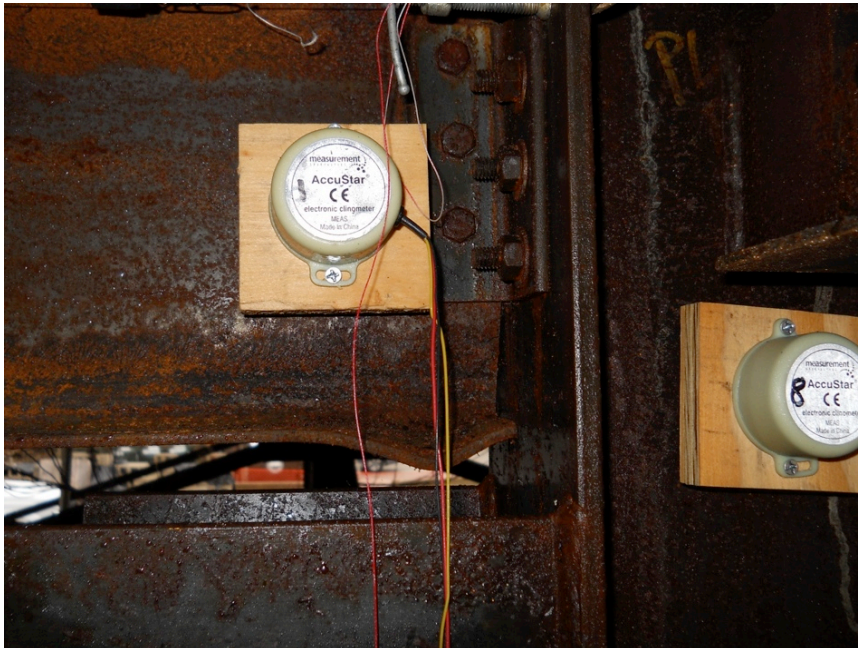
Figure 4.4 EC-B Test Evidence of Girder Flange Bearing on Column

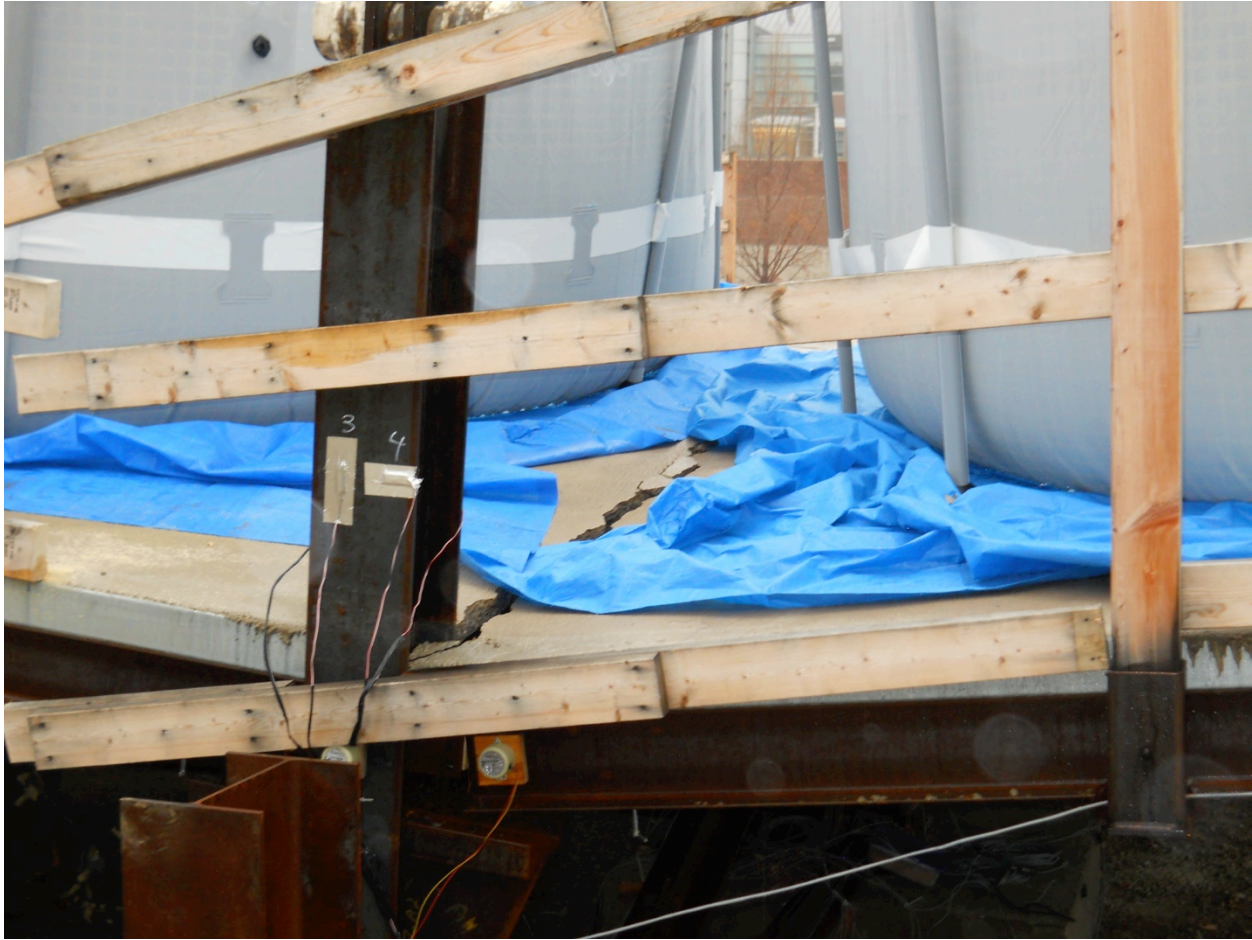
Figure 4.5 EC-B Test Post-failure Deck Crack on Girder Line

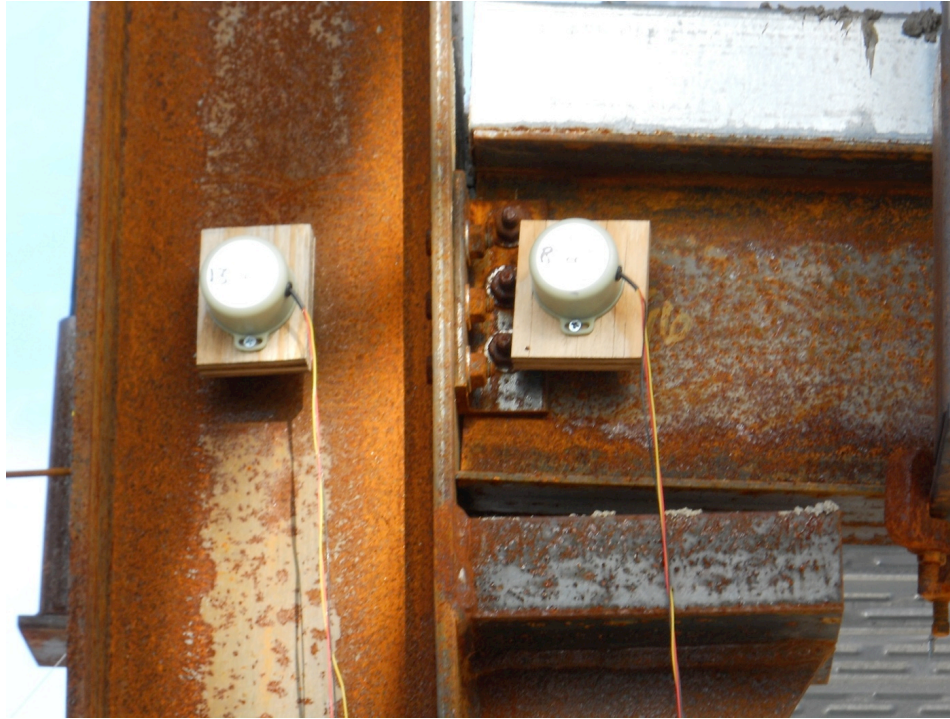
Figure 4.6 EC-G Test West Girder Bottom Flange Bearing on Column D4

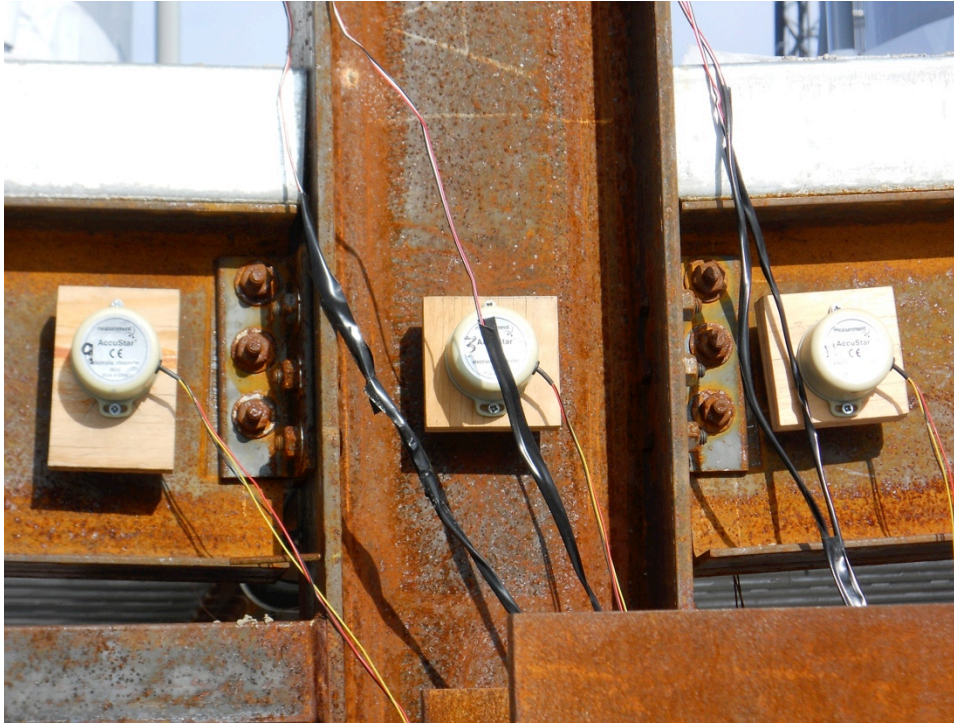
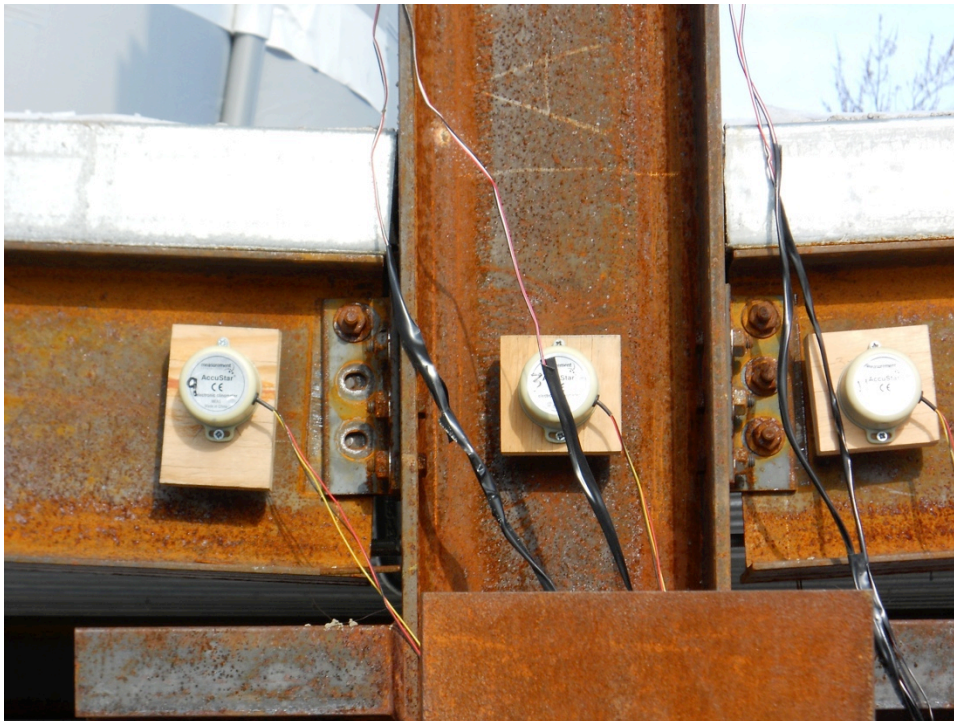
(a) Final Equilibrium (6.3 in. Displacement, 84 psf)

(b) Floor Failure (6.8 in. Displacement, 89 psf)

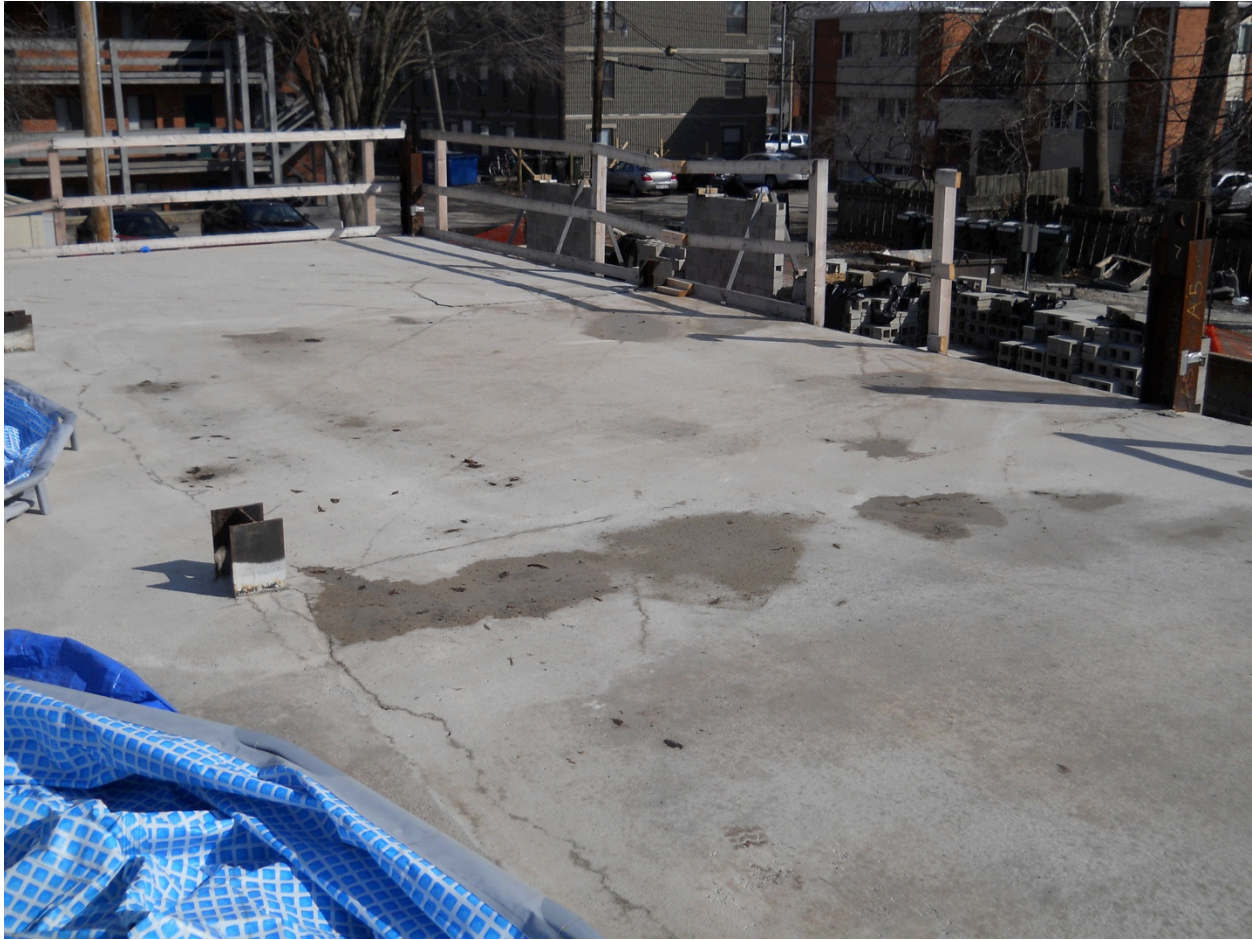
Figure 4.8 EC-G Floor Cracking Pattern

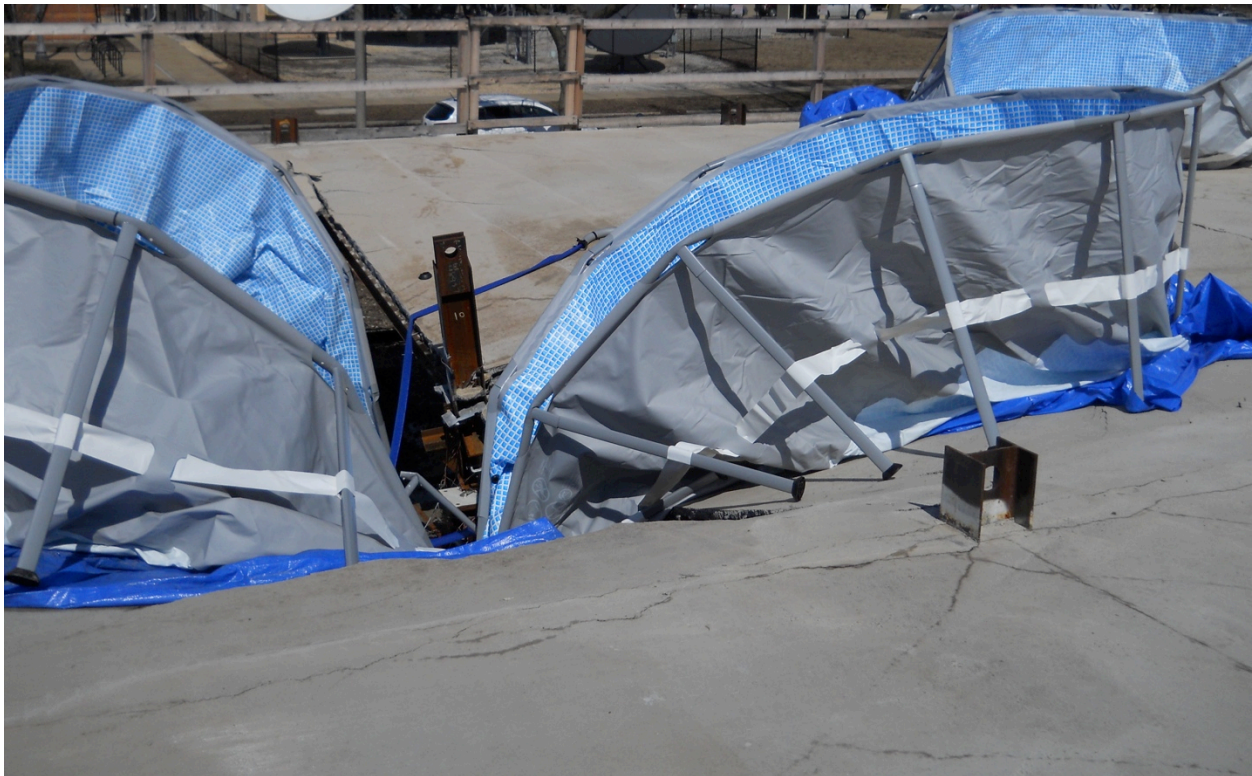
Figure 4.9 IC Test Floor Collapse Seen from Above

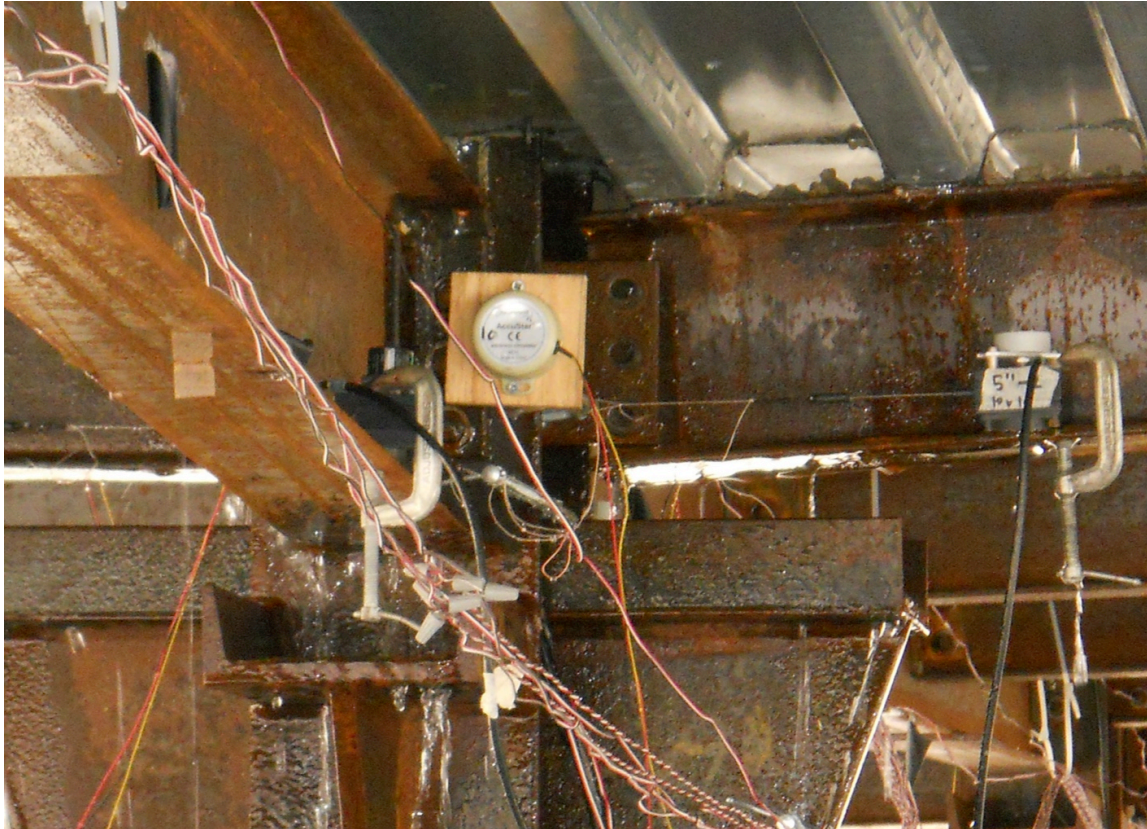
Figure 4.10 IC Test Failure of South-Beam-to-Removed-Column Connection
